# Partners Newsletter

March 2017

# Biofouling in internal pipework of recreational vessels

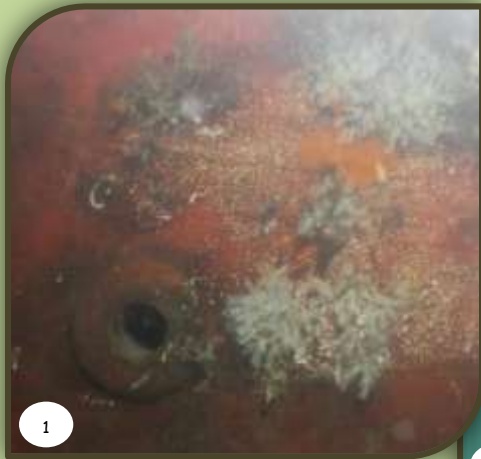
Photo 1: Fouling assemblage around a seawater intake fitting – but what lies within the pipework?

Preventing biofouling through regular vessel maintenance is the best way to manage biofouling risk but it's sometimes necessary to treat fouled vessels on arrival. Vessel niche areas, including internal pipework, are recognised as biofouling hotspots, but little knowledge exists about treating the internal pipework of recreational vessels.

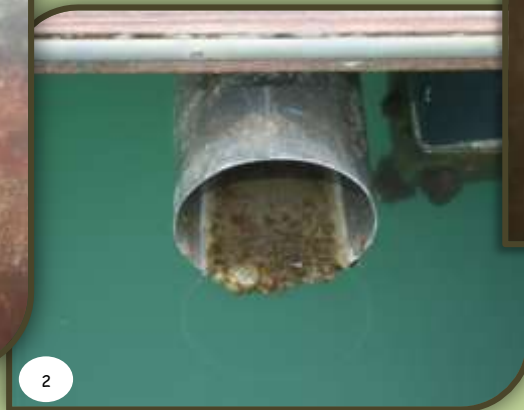
Photo 2: Bladder weed (*Colpomenia* spp.) fouling the engine exhaust of a recreational vessel.

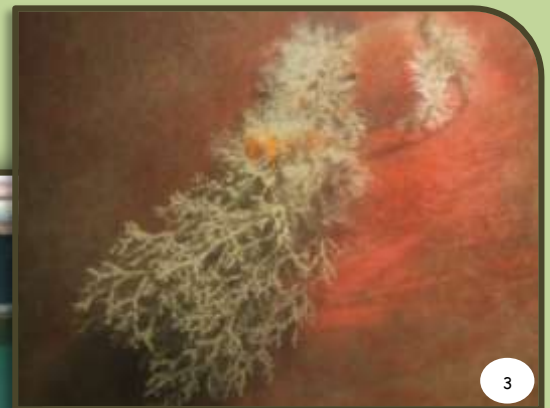
Photo 3: A fouled intake grate on a recreational vessel. The light-bulb sea squirt (*Clavelina lepadiformis*) and spaghetti bryozoan (*Zoobotryon verticillatum*) are conspicuous members of this fouling assemblage.
